Maxwell Windlass Model VW-800
Catalina 36 MK-II #2164 - Windlass Maintenance

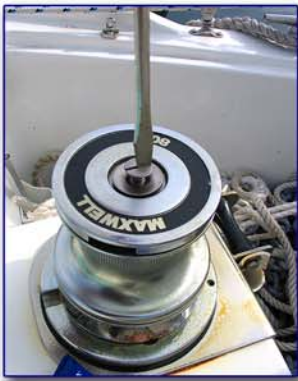
Remove Rubber Cap, screw and washer

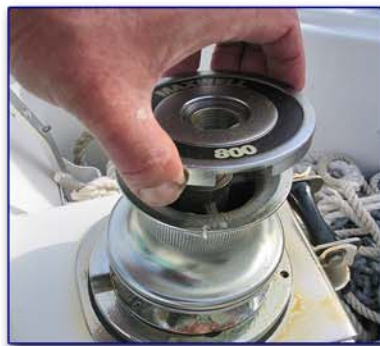
Unscrew (counterclockwise) top

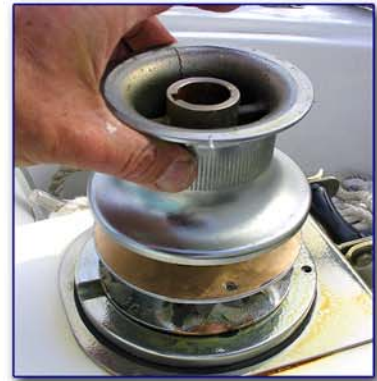
Lift drum vertically on keyed shaft

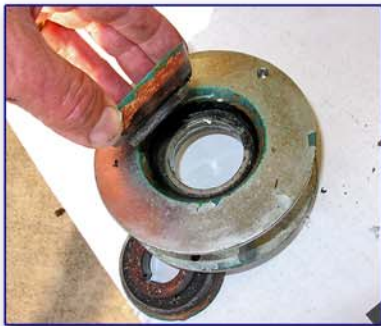
Remove clutch assembly off shaft.
Brass cones may need to be pushed out by screwdriver if stuck (mine were).
Note heavy corrosion.

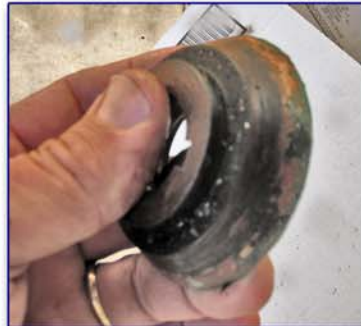
Heavy corrosion on clutch cones

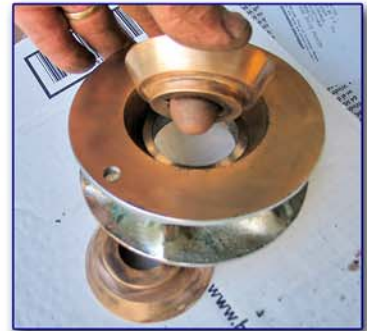
Clutch assembly after cleaning with solvent & wire brush. I applied "Lewmar Greargrease" (or see Maxwell specs) to clutch surfaces.

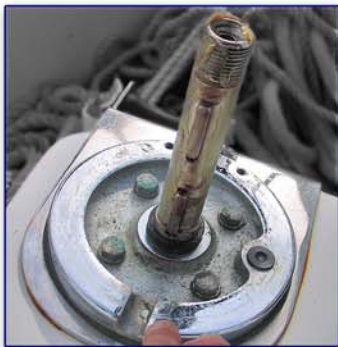
Windlass base prior to re-assembly
- grease shaft & threads.

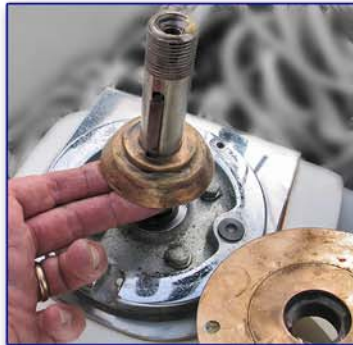
Re-assemble 3 pc brass clutch on shaft over 2 keys

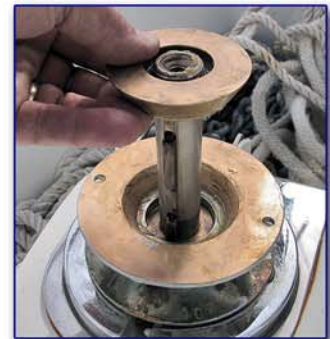
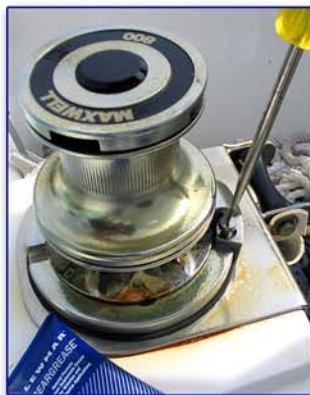
Slide drum back over shaft, screw on the windlass top plate, tighten screw/washer, replace rubber cap.
Replace two screws holding the "chain-deflector" device (?) (left), spray with corrosion inhibitor as per Maxwell suggestion.
(Residue on left is this inhibitor)
